Construction of the Micoud Wellness Center

Disaster Vulnerability Reduction Project

**Final Report on the Implementation of the
Abbreviated Resettlement Acton Plan**

Structural Assessment: Micoud Wellness Centre

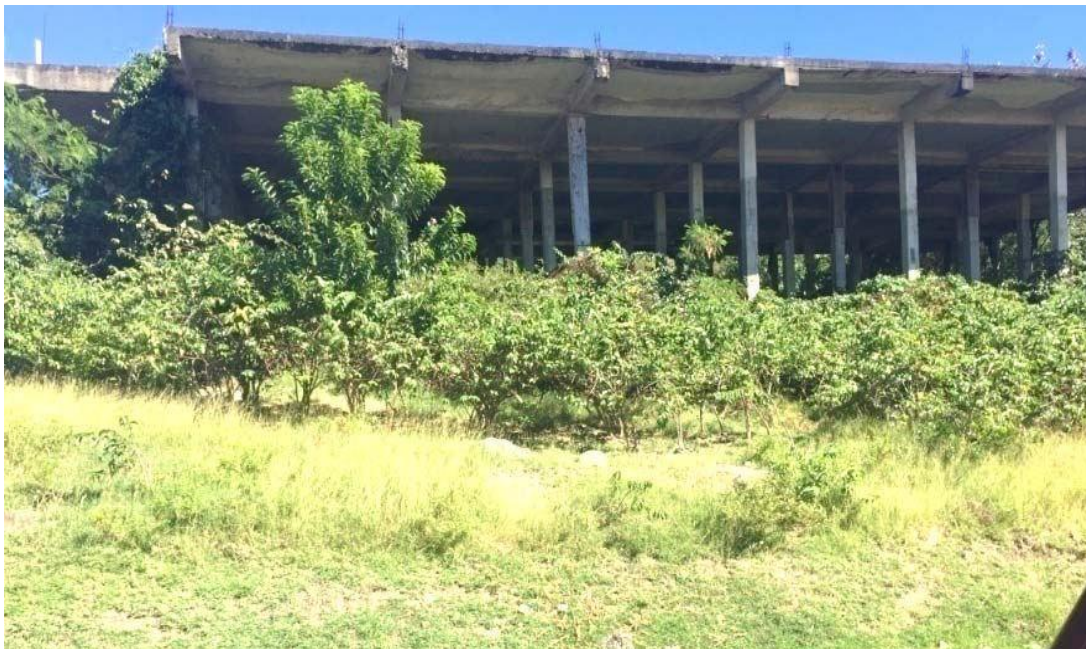
Illustration i: Structure which was acquired

The structure was intended to be a two-story building for the purposes of meetings and recreational activities of the Micoud Mothers and Fathers Group. The construction was halted in 1992 by the Department of Physical Planning as the structure was found to be structurally unsound. Construction was discontinued which led to the columns and slab becoming dilapidated over the years.

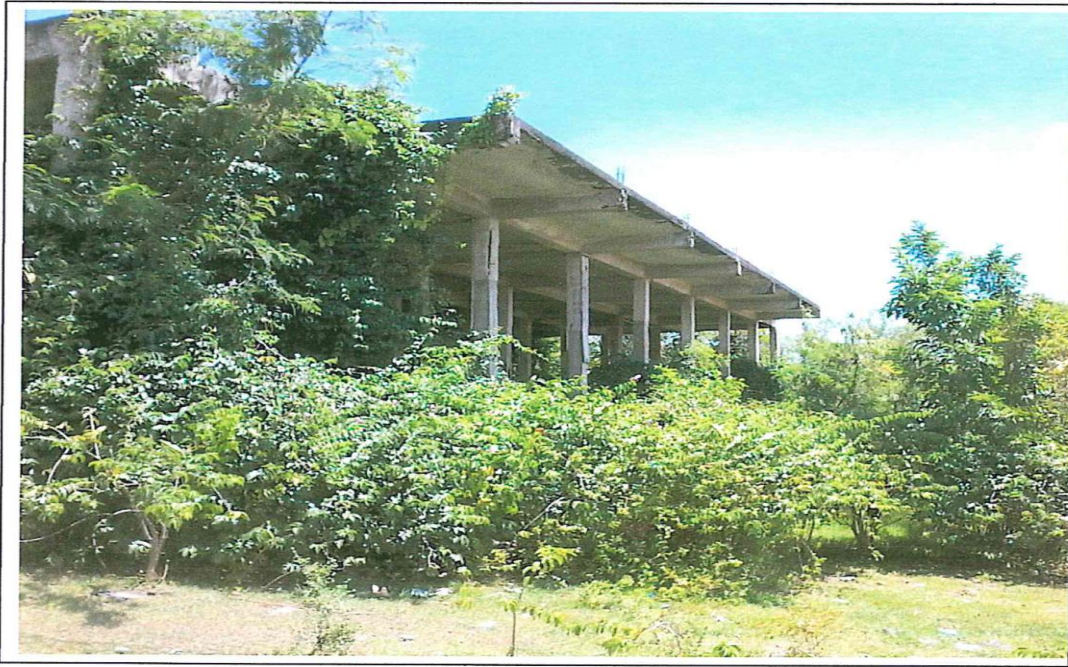
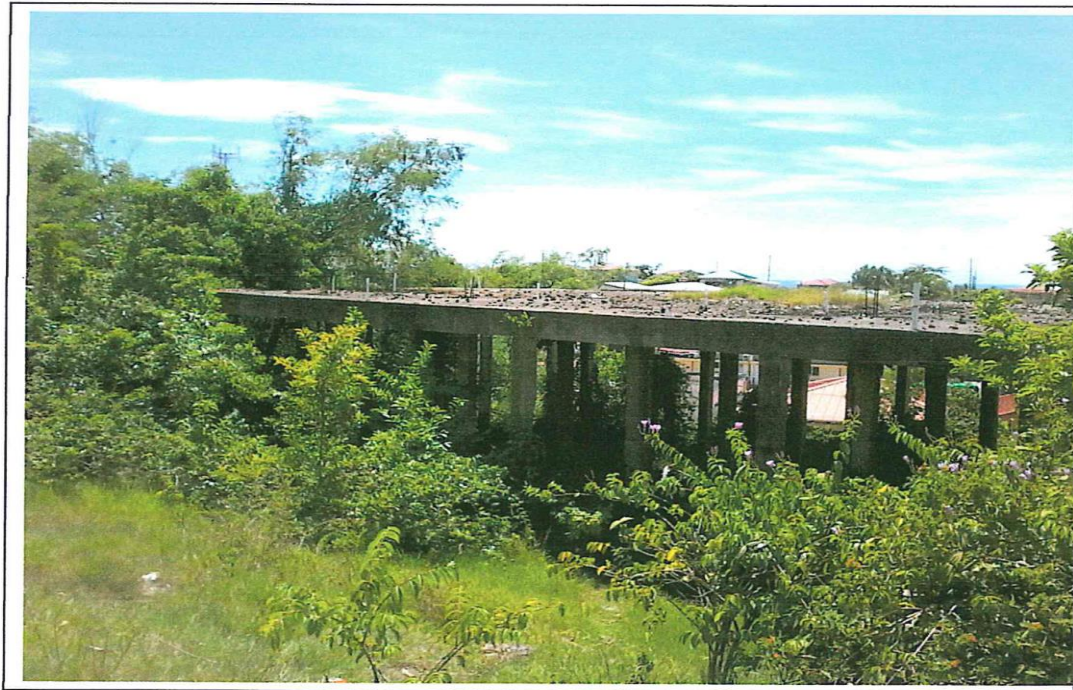
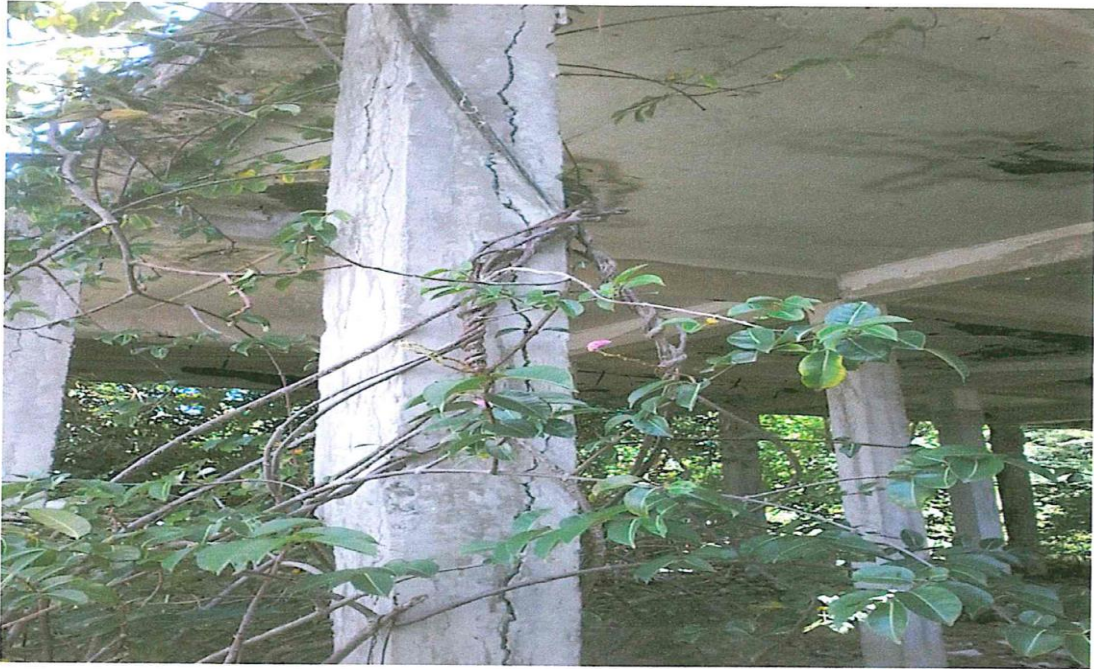
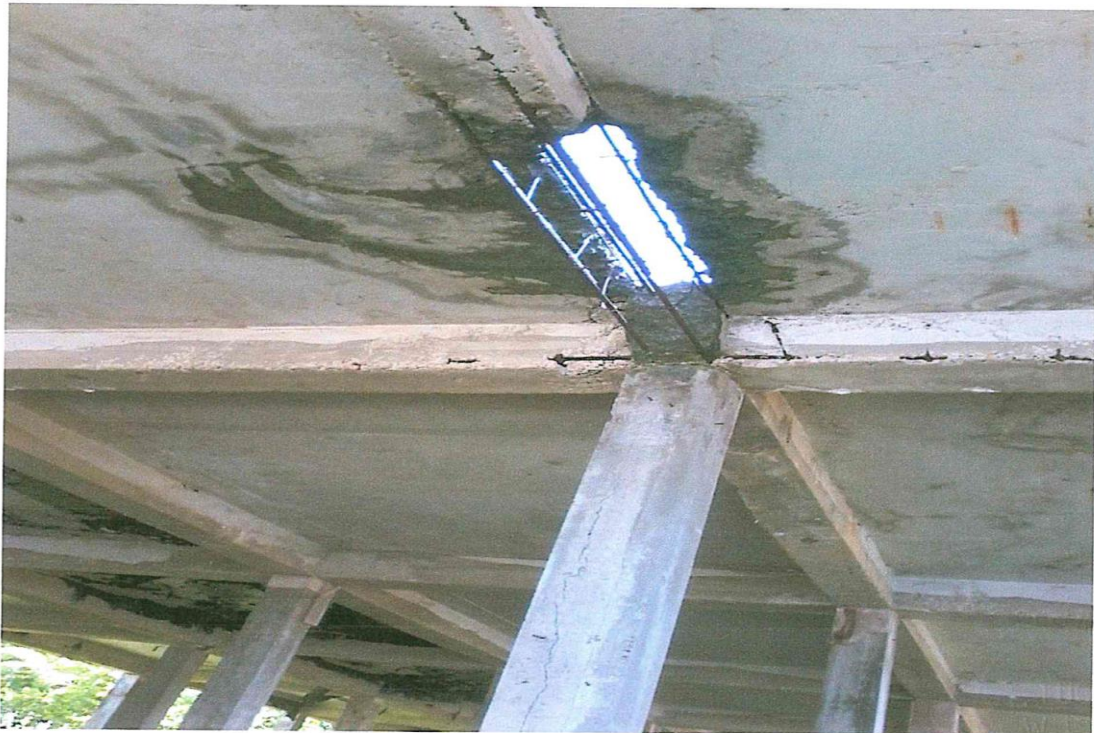
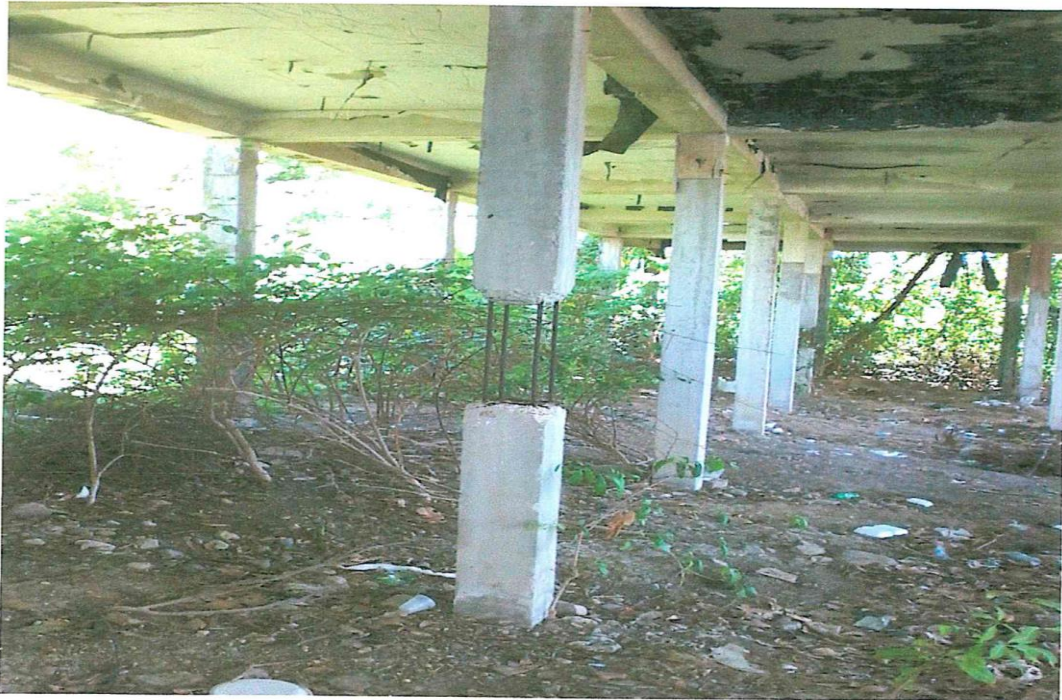
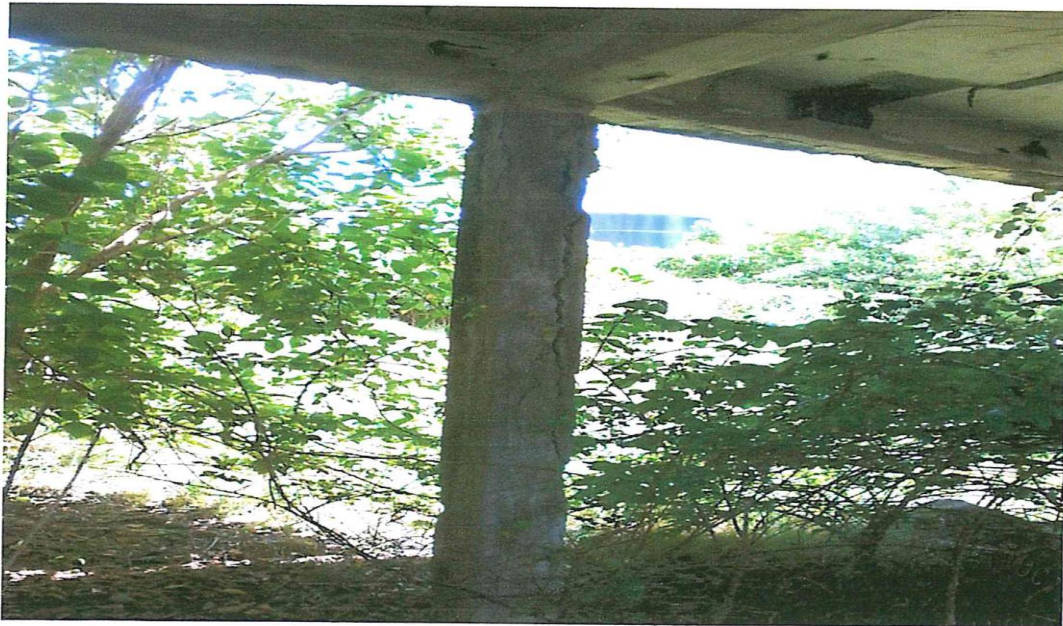
The structure is structurally compromised and cannot be used or repaired for the intended purposed and therefore would have to be demolished.

The component that is mainly compromised are the columns which provide structure support to all beams and slab and is at risk of collapsing under the load of the supported components or any further loading of the structure. Refer to photos.

Estimated cost of demolition inclusive of carting away to landfill: EC \$12,600.00

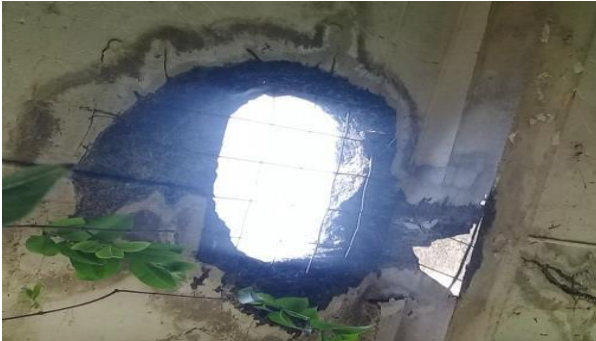
Photo 2

- a) There are three (3) sections in the concrete slab with openings as shown in Diagram 1 in bays C-D, D-E and E-F (see photos 2 and 3). Near this area the concrete has broken up, flaked and become pitted. The concrete slab has water stains which are damaged caused by rainwater.

Performing remedial repairs to the building would be very expensive such as: replacing all columns, beams, slabs and foundation. The optimum solution is that the building **be demolished** and should not be retrofitted for any other use.

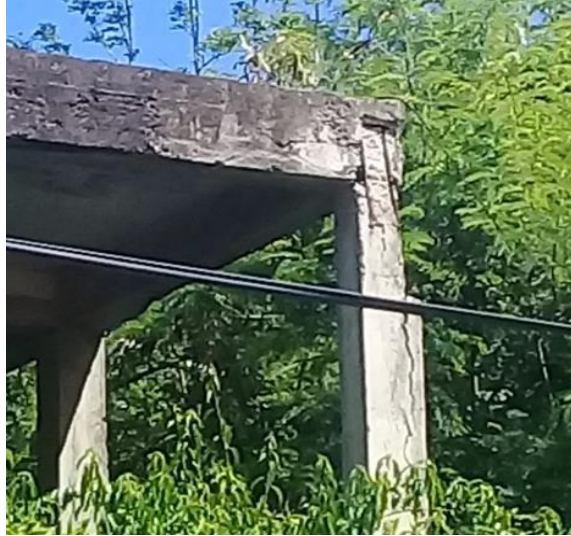
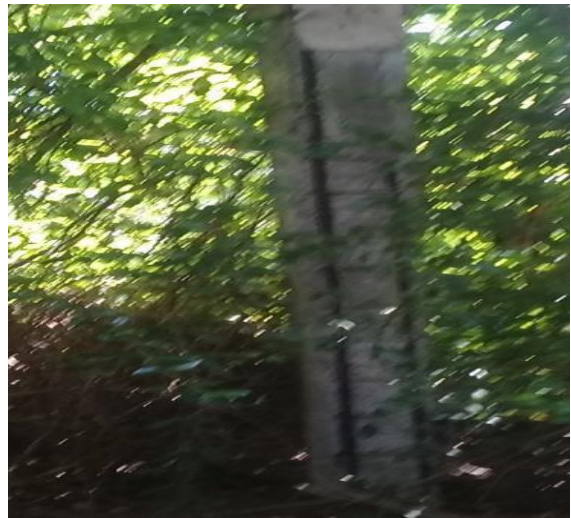
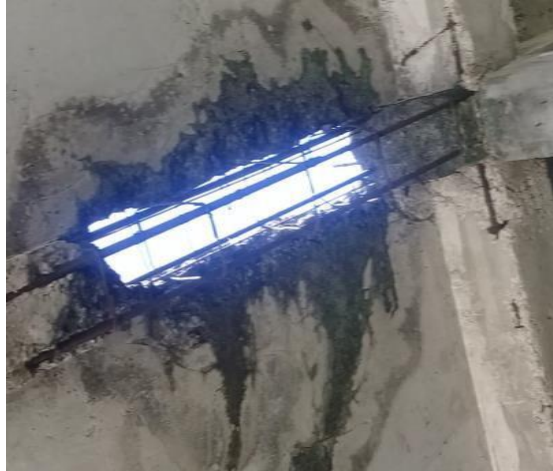
Photo 4, 5 and 6 concrete columns damage

The building's columns are failing, the columns which are supporting the suspended floor of the building has longitudinal cracks measuring approximately 8m (height of columns). All the columns in the structure show signs of structural failure.

- a) Photos 4 and 5 indicate some of the longitudinal cracks along the columns. The reinforcement in some cases is exposed and appears to be caused by the rebars expanding due to moisture. The moisture causes displacement of the bars and causes the concrete cover to crack and break off. The columns appear not be plastered.
- b) There are five (5) columns with missing concrete and the reinforcement is exposed as indicated in Diagram 1 (columns A1, E2, C4, E6 and E8)(see photo 6). It is difficult to determine if this is caused by vandalism or intentional by the contractor.

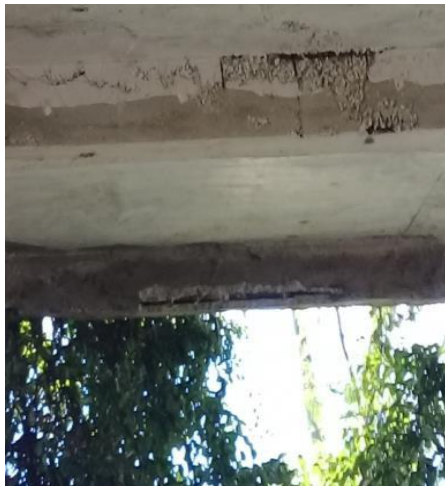
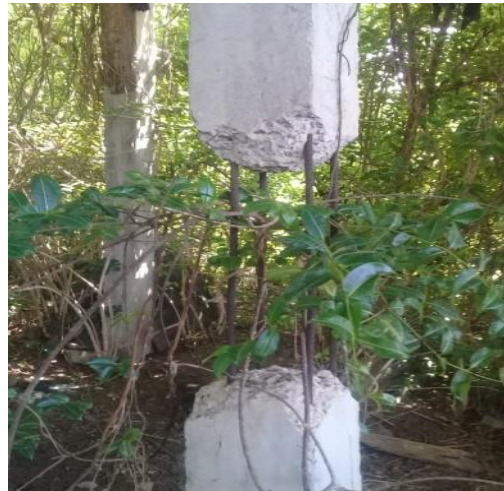
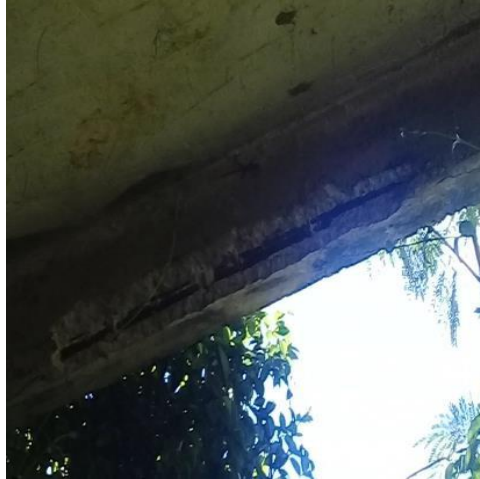
Photo 7, 8 and 9: concrete beams damage

a) There is spalling of the concrete beams, the concrete has broken up, flaked and become pitted (see Photo 5,6 and 7). There is a large portion of a beam with the reinforcement of the concrete beams are exposed, the rebars have rust and expanded approximately 2 times its original size causing concrete displacement.
